### Site 328 Rings Island – First Street and March Road

Great Marsh Coastal Wetlands Restoration Plan  
Rapid Technical Assessment Site 328

# Site 328: Rings Island, 1st St./March Road, Salisbury, MA

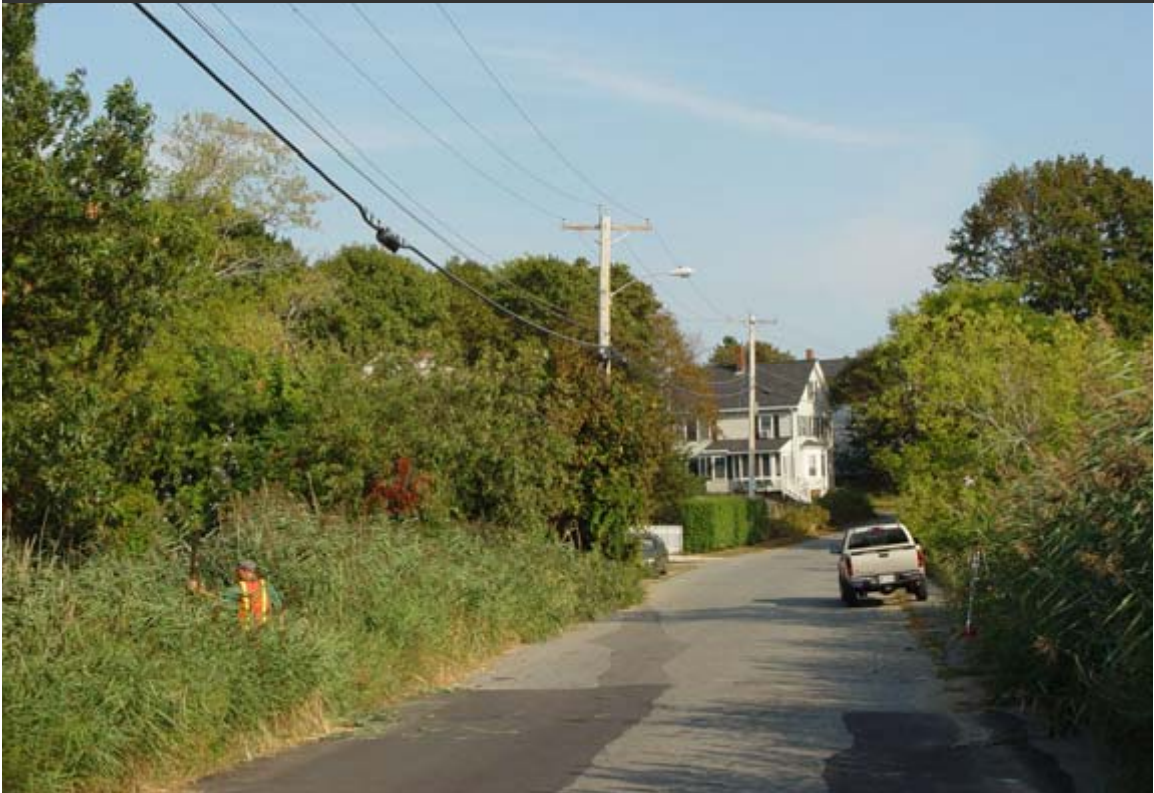
**Photo 1 - First Street Viewing East**

**Structure conditions:** Both ends of the existing culvert under First Street are obscured by riprap and accumulate wrack and debris which prevented visual inspection. The approximate length of the culvert is 40 ft. The culvert appears to be a severely deteriorated timber box culvert of unknown dimensions. The likely original size of the structure is 4 ft by 2 ft (D. Levesque, DPW Director, pers. comm.). Overall, the culvert is considered to be in poor or failed condition. A more thorough inspection would require cleaning and maintenance at the inverts. The life expectancy of the culvert is less than 5 years. First Street is approximately 26 ft wide with a sidewalk on the downstream side of the road and cable guardrail on both sides. The roadway is showing minor signs of collapsing near the culvert but is in fair overall condition with recent major patching of the roadway surface.

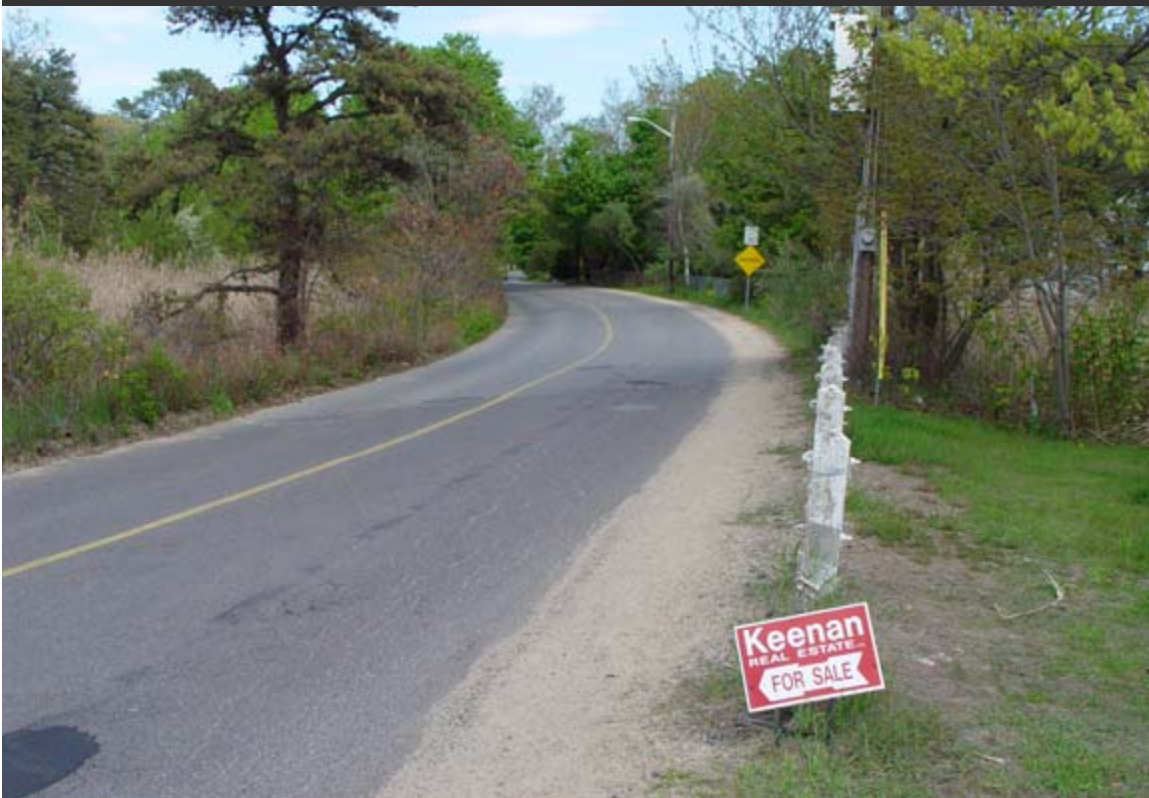
**Photo 4 - March Road Viewing East**

The second culvert is an 18 in RCP culvert under March Road. The downstream end of the culvert is located within the triangular-shaped marsh within the median between the two roads. The upstream end of the pipe connects to a linear ditch which parallels March Street for approximately 95 ft before veering to the north. The downstream end of the culvert is protected by a concrete end section while the upstream end has no protection from scour or erosion. The approximate length of the culvert is 53 ft. Overall, the 18 in culvert under March Street is in fair condition with a life expectancy of over 25 years. March Street is approximately 30 ft wide with broad shoulders and cable guardrail on both sides. The roadway is in good condition.

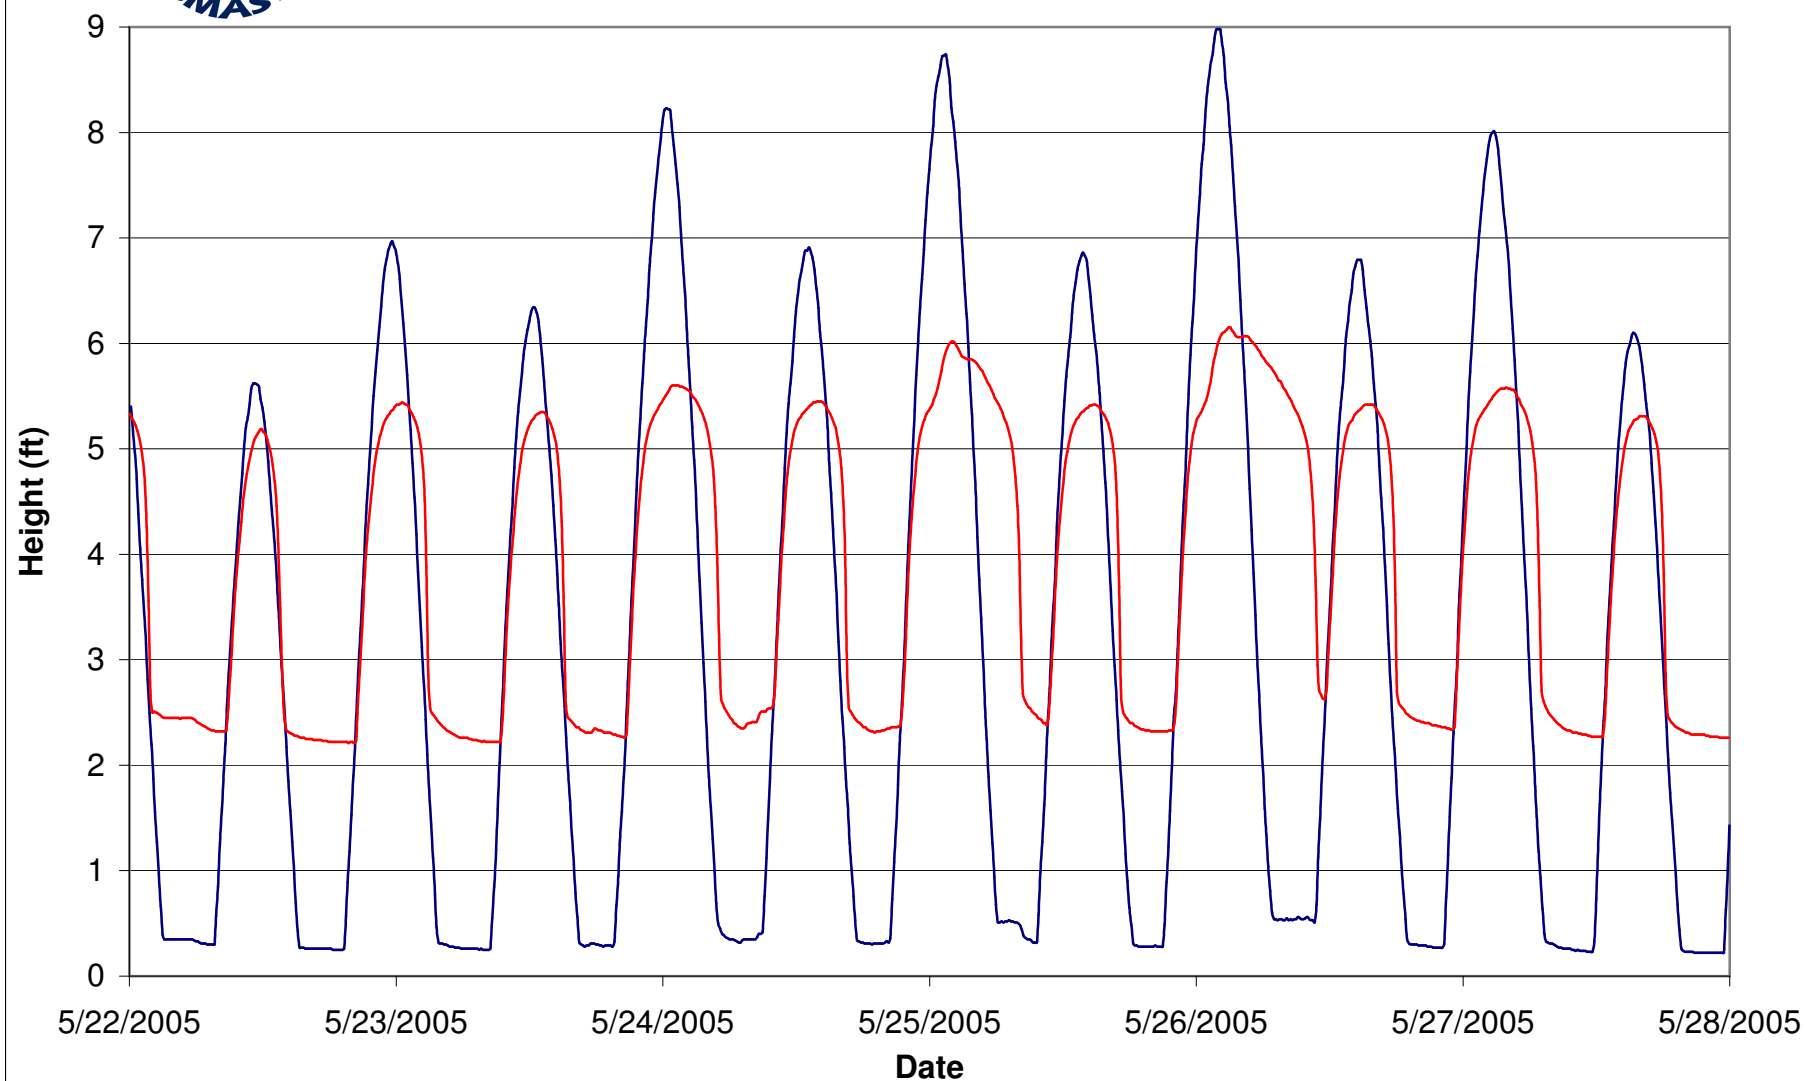
Two tide gauges were deployed from May 18 to June 3, 2005 upstream of the culvert under March Road and downstream of the culvert under First Street. Results of the gauge deployment show a significant restriction of tidal flow through the culverts which increases with tidal prism. These restrictions occurred during all of the 29 tidal cycles recorded for this deployment. Tidal restrictions ranged from 0.43-2.83 ft and delays ranged from 35 min to 1 hr 5 min. The highest recorded tide downstream of the culvert occurred during a major coastal storm on May 26 at 1:49 AM at an NGVD adjusted height of 8.98 ft. Upstream high tide occurred at 2:54 AM at an adjusted height of 6.15 ft. During the peak of the tidal cycle, the roadway system was overtopped causing a pronounced delay in the ebb tide upstream of March Road. The resulting tidal dampening was 2.83 ft. and a delay of 1 hr 5 minutes. The dampening amounted to approximately 33% of the total tidal prism recorded at the downstream gauge. The dampening effect provided flood protection to relatively low-lying properties along First Street and Route 1. The tidal restriction during more typical spring tide conditions (similar to the tide which reached elevation 5.5 ft on May 22<sup>nd</sup>) is approximately 0.4 ft.
